EGYPT, PETRO AMIR

WHEN A 7" STRING WAS DROPPED TWICE, RE-USE OF CENTEK CENTRALIZERS SAVED THE OPERATOR 18 HOURS RIG TIME, NEARLY \$20,000 (USD) EQUIPMENT VALUE AND SECURED THE WELL

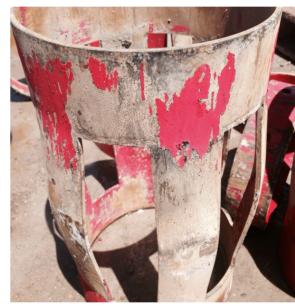
The Centek S2 single piece construction gives it robustness and strength which exceeds that of competitor products. Although Centek does not recommend the re-use of centralizers after they have been pulled out of hole this case study proves that even when subjected to extreme stresses the unique design of Centek centralizers meant that they remained in good condition and could be used repeatedly.

The use of Centek S2 centralizers meant that each time the liner was re-run the centralizers were in good condition. There was no damage from falling off the liner after RIH several times, two re-runs and a fishing operation.
